Corrosion

Official Publication

NATIONAL ASSOCIATION OF CORROSION ENGINEERS

CORROSION—January, 1952

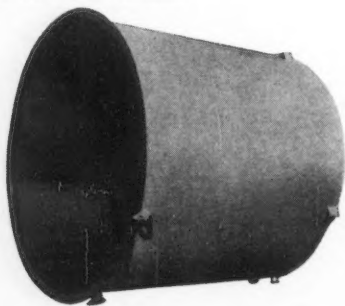
**T-LOCK AMER-PLATE
for newly cast
concrete pipe
and structures**

T-shaped parallel "anchors" are an integral part and extend along the back of each Amer-Plate sheet. The sheet is applied to the inner forms of tanks, concrete pipe, and structures. When the concrete is poured, the tees are embedded and locked into the concrete.

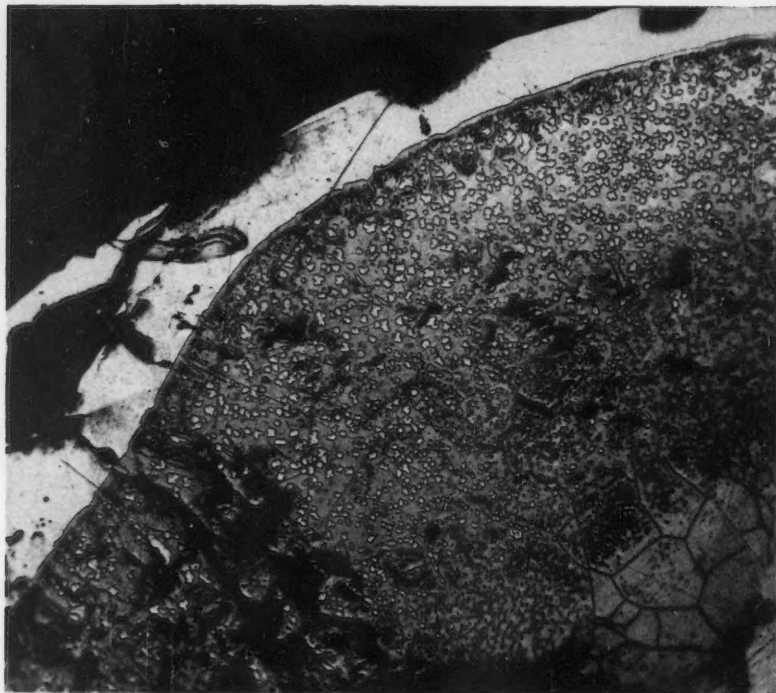
Figure 9—Oxide scale on Armco iron after two hours and five minutes at 2000 degrees F (1090 degrees C) in pure oxygen. Changing from adherent to separated oxide. See Figure 7 for key to position on specimen. X120. Etchant 20 percent HCl.

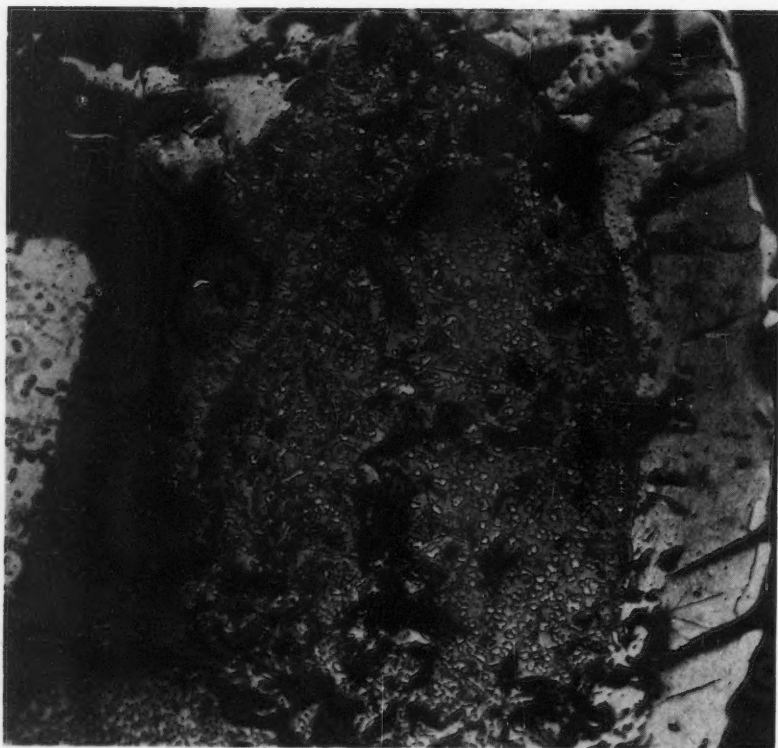
Figure 10—Oxide scale on Armco iron after two hours and five minutes at 2000 degrees F (1090 degrees C) in pure oxygen. This is a separated oxide. See Figure 7 for key to position on specimen. X120. Etchant 20 percent HCl.

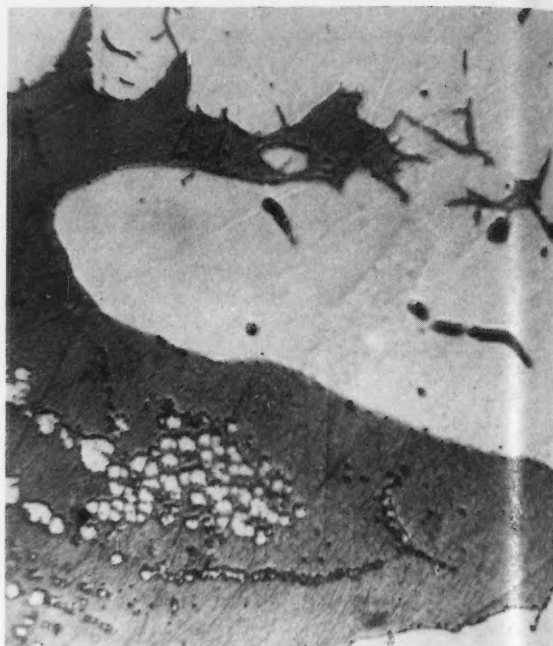
Figure 19— Fe_2O_3 precipitate in FeO . Oxide formed on specimen of Armco iron oxidized in pure oxygen at 2000 degrees F (1090 degrees C) for two hours and five minutes. Dark areas are FeO and light areas are Fe_2O_3 . X1300, Etchant 20 percent HCl.

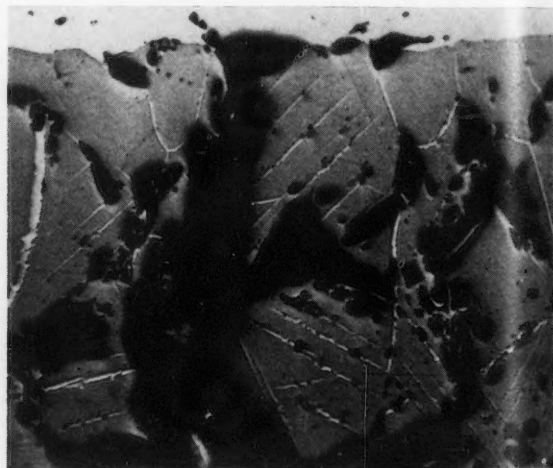
Figure 20— Fe_2O_3 precipitate in FeO . Oxide formed on Armco iron in pure oxygen at 2200 degrees F (1205 degrees C) for one hour and 20 minutes. X155, Etchant 20 percent HCl.

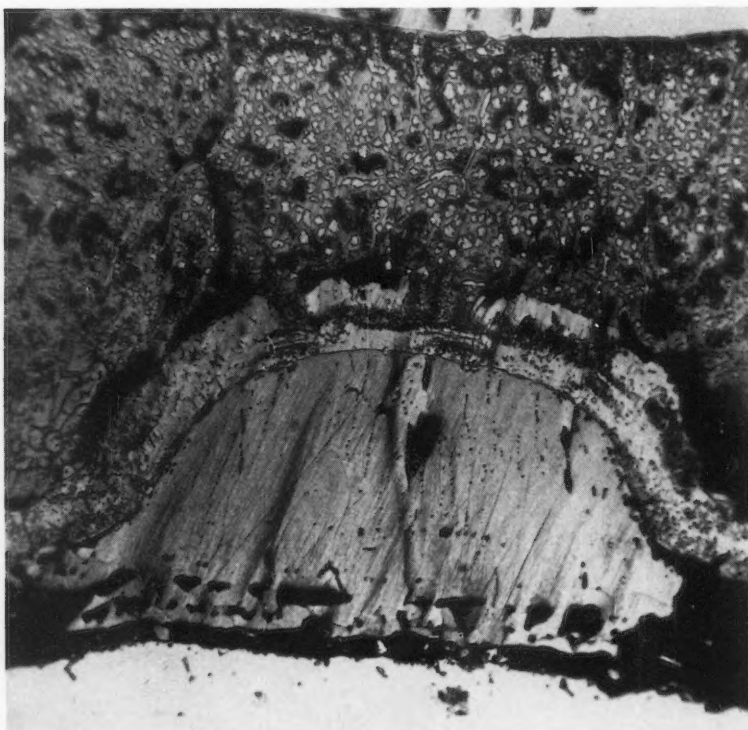
Figure 24—Oxide and blister formed on Armco iron heated in dry air to 2000 degrees F (1090 degrees C) for three hours. X120. Etchant, 20 percent HCl.

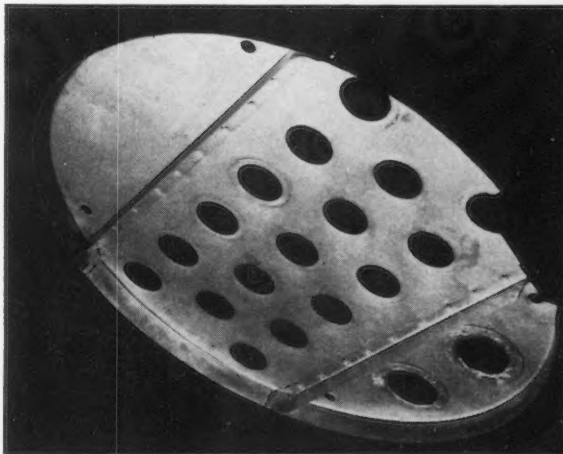
Figure 1—Type 316 stainless steel bubble cap tray No. 27 of a 40-tray acetic acid recovery column.

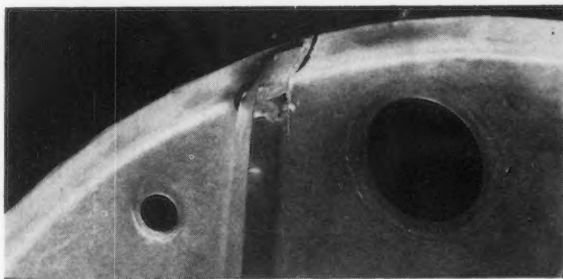
Figure 2—View from upper side of tray No. 27 showing attack in heat affected zone where the weir was welded to tray flange.

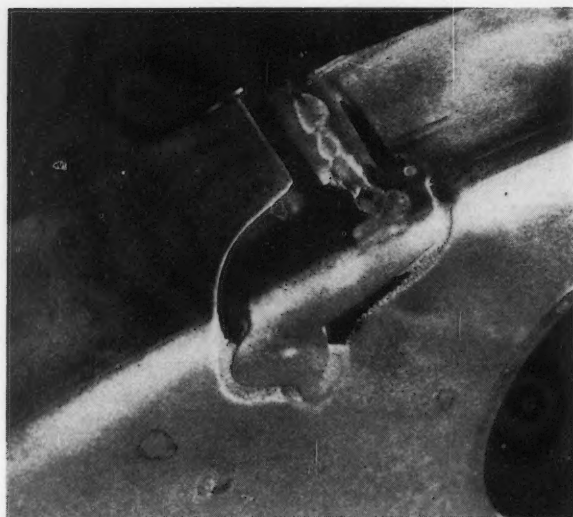
Figure 3—View from underside of tray No. 27 showing attack in heat affected zone where the weir was welded to the tray flange.

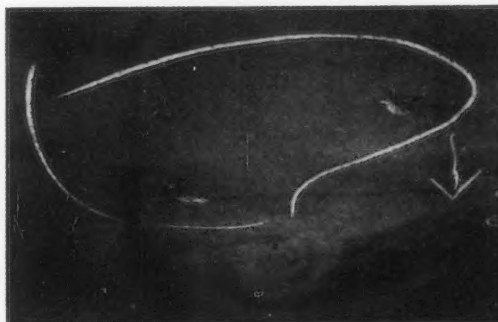
Figure 2—Typical severe pitting of bottom plating on a new vessel, ten months after delivery. These pits averaged 1/4-inch in depth.

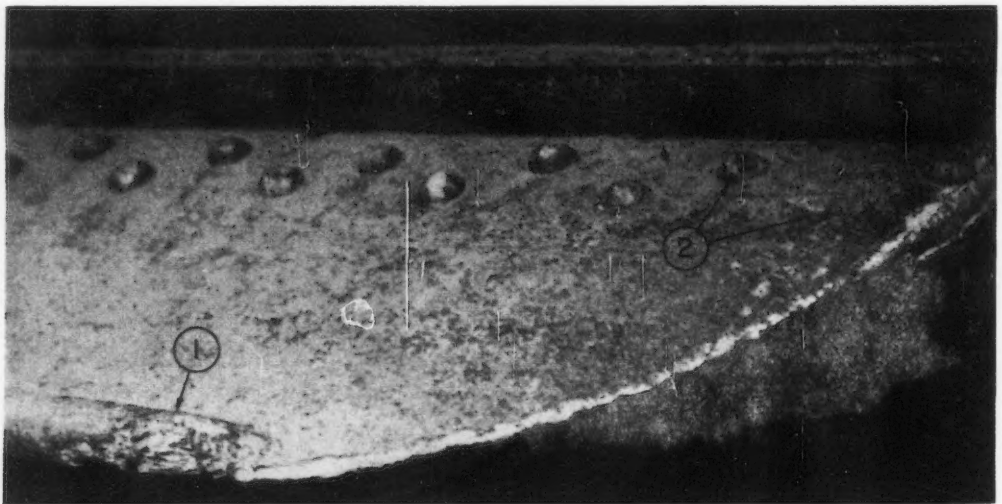
Figure 3—Corrosion activity due to water velocity at forward edge of a bilge keel. Note how the half-round (arrow 1) has been attacked and that some rivet heads (arrow 2) have corroded severely. Ship in service about three years.

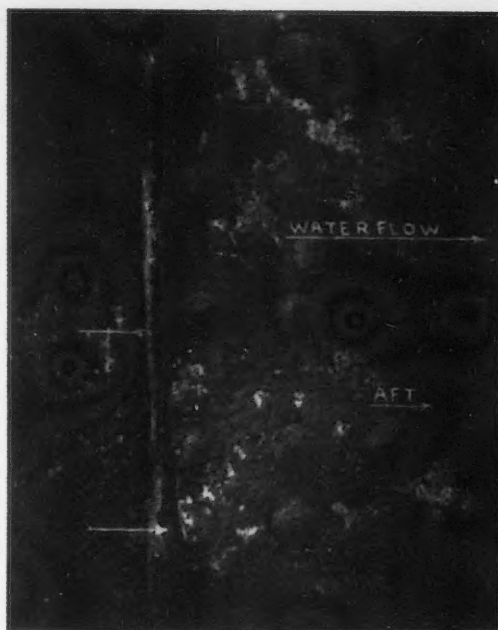
Figure 4—Corrosion (arrows) at forward edge of a riveted lap on a ship in service nine months.

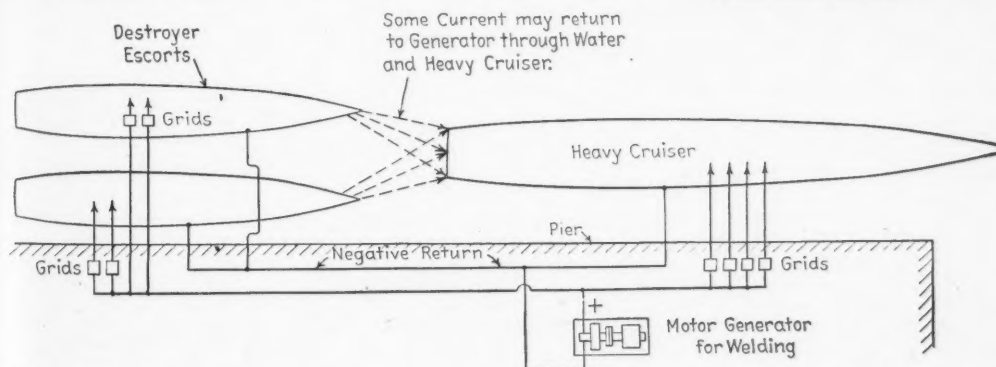
Figure 6—Welding wiring diagram of two destroyer escorts and one heavy cruiser outfitting at the same time. Note that when welding on the escorts current may leak to the cruiser and follow the cruiser negative return to the generator.

Figure 9—Showing increased capacity of negative returns to generator and bonding between ships. Circled numbers indicate size of cable in circular mils. Compare with diagram shown in Figure 6.

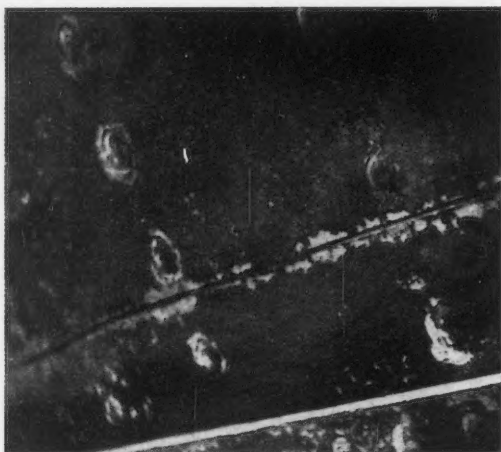
Figure 7—The paint on the plating of this vessel was scratched when fore poppets were removed after launching. Stray welding currents were focused on the bare steel, which resulted in severe localized corrosion in excess of $\frac{1}{8}$ -inch deep.

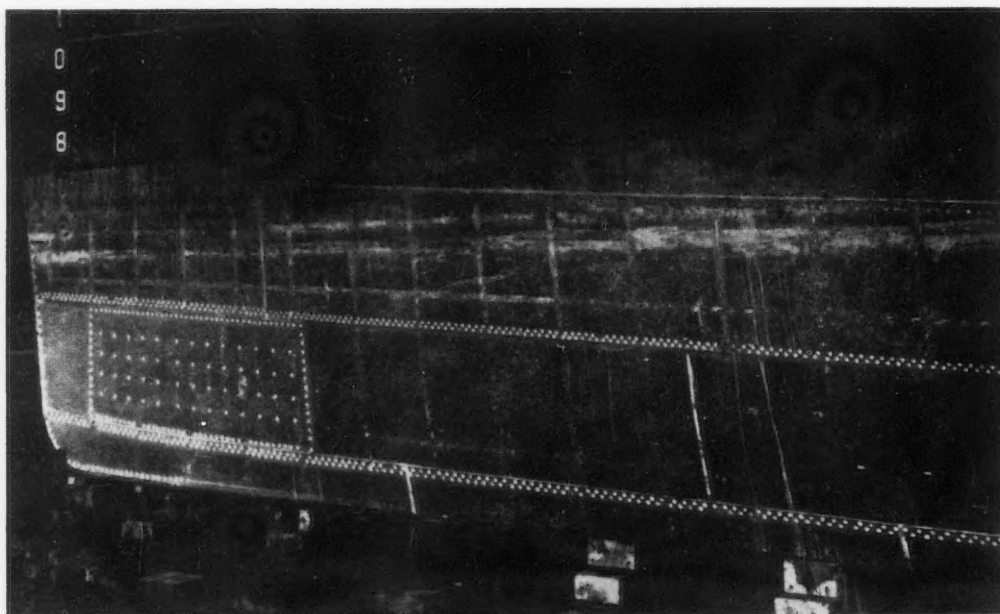
Figure 8—Example of white salt deposits, resulting from stray welding currents, on the underwater hull when a vessel was the cathode in the welding circuit. Note how deposits are concentrated on rivet points and in way of welding on the inboard surface of the shell, where the heat effect has caused the paint to deteriorate.

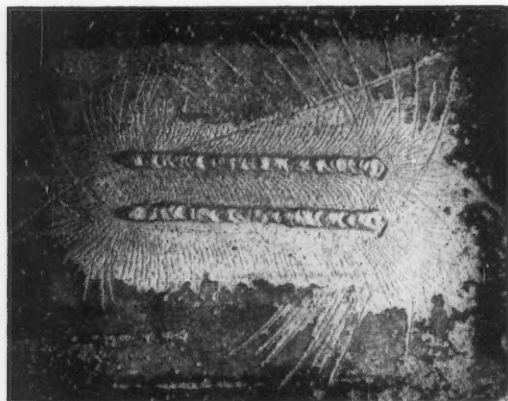
Figure 11—Shrinkage from the welding on this plate cracked the mill scale and exposed areas of bare steel. The plate was immersed in sea water for only 30 days. Concentrated corrosion to a depth of 1/32-inch has occurred in the breaks in the mill scale. Note how the corrosion has a slight tendency to undermine the mill scale at the cracks, etc.

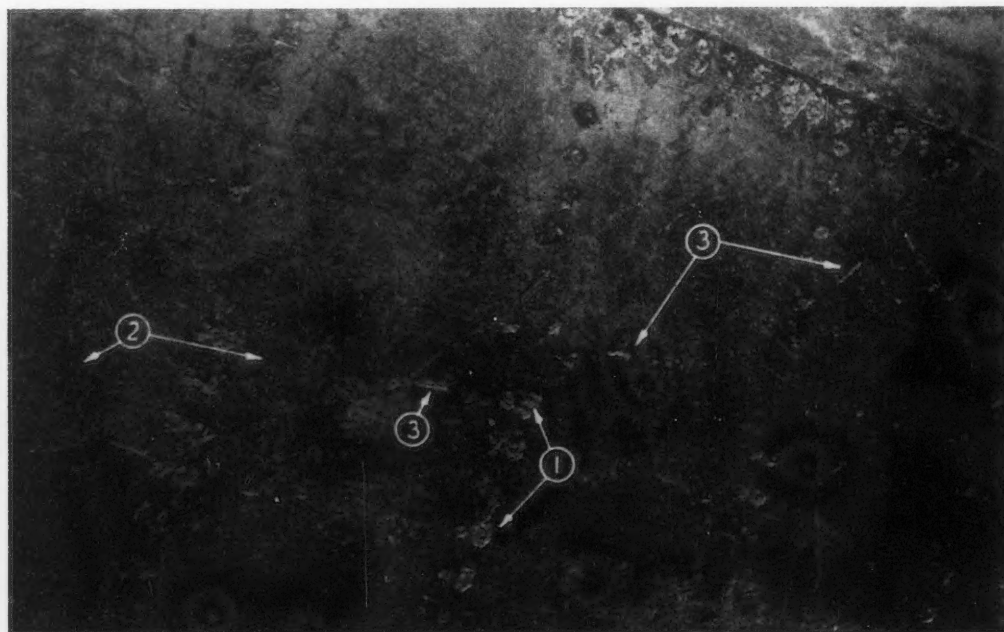
Figure 12—Mill scale corrosion on a vessel seven months after delivery. Note attack at rivet points and adjacent plating (arrows 1), white deposits of mill scale (arrows 2) and attack on bare steel (arrows 3).

Figure 16—Extensive white deposits (arrows) denoting the presence of mill scale. Figures 1 and 12 are close-ups of the plating of this vessel on which 90,000 rivets were replaced.

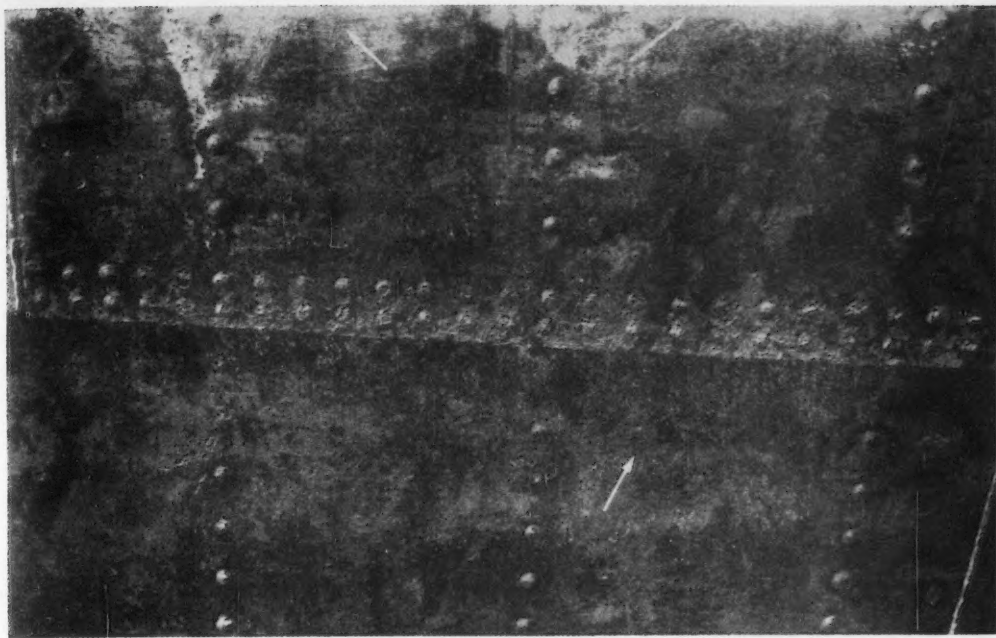
Figure 13—Mill scale corrosion of rivet points and adjacent plating on a new vessel after twelve months in service. Note white deposits (arrows).

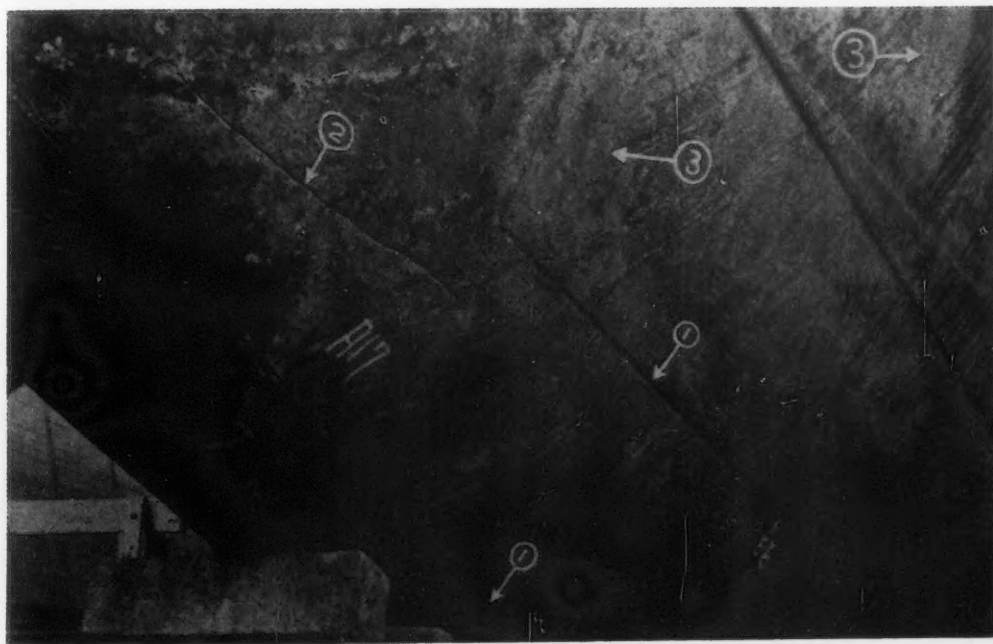
Figure 14—Typical example of weld metal corrosion (arrows 1) caused by mill scale on adjacent plating. Welds were corroded to below the level of the plates and about two thousand feet had to be built up. Note corrosion on plate (arrows 2) and white deposits (arrows 3). This vessel was built abroad and most of the shell plating was of British manufacture.

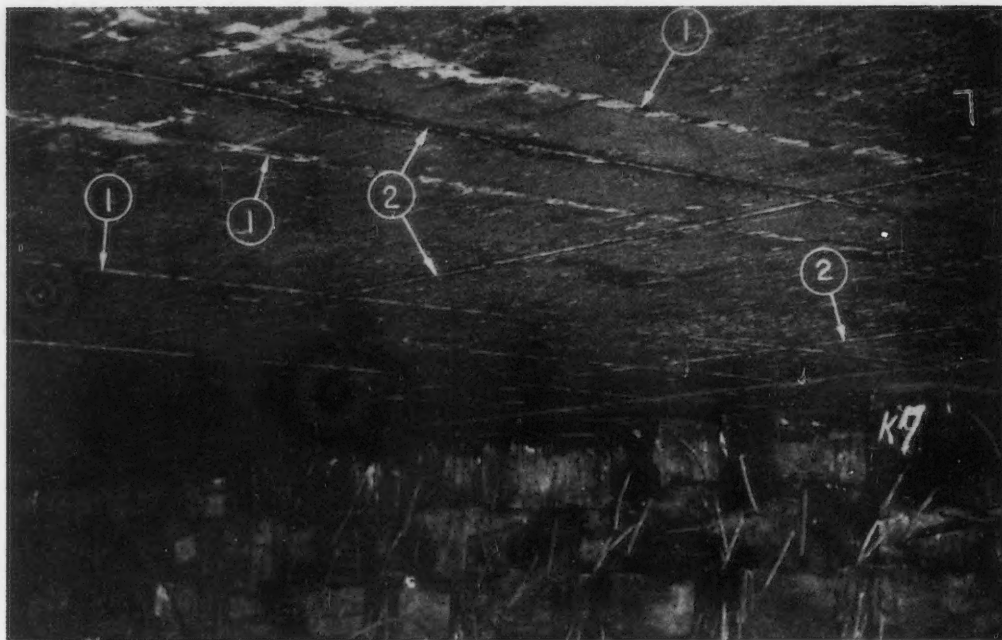
Figure 15—Extensive corrosion (arrows 1) on the bottom of the hull, opposite welds connecting floors to the plating. The heat effect caused the mill scale to crack off on the outside and has exposed bare steel to corrosive attack by mill scale remaining on the unheated areas. Severely corroded welded seams and butts are indicated by arrows (2).

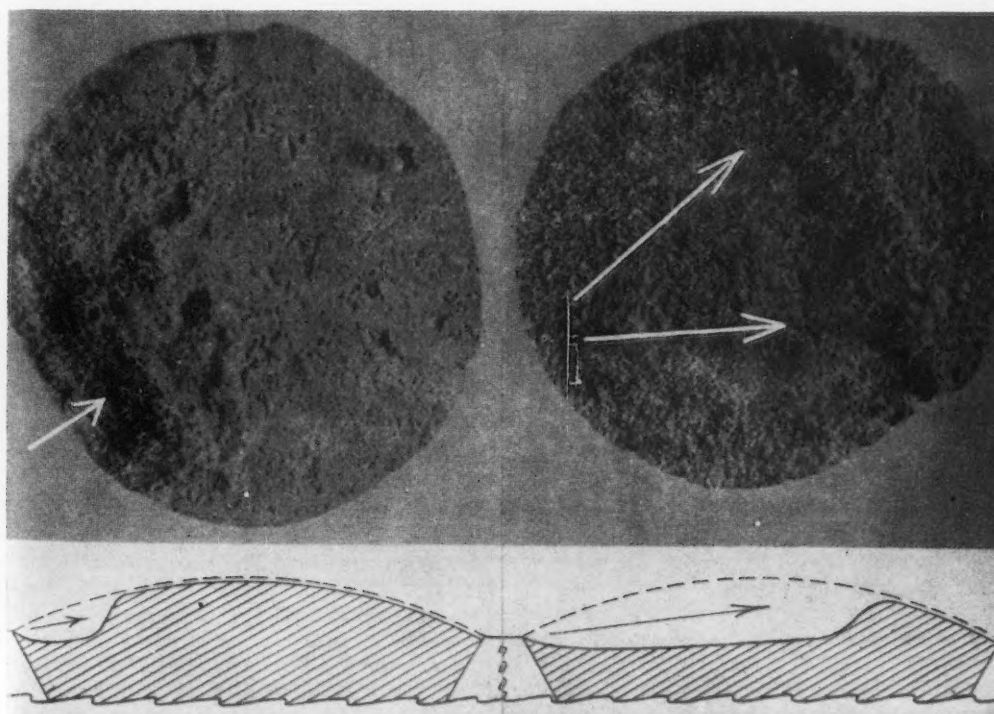
Figure 18—One edge of a flush rivet is likely to be free of heat scale after driving. Galvanic corrosion strikes here first (above, left) and travels across the rivet point as it increases in depth (above, right).

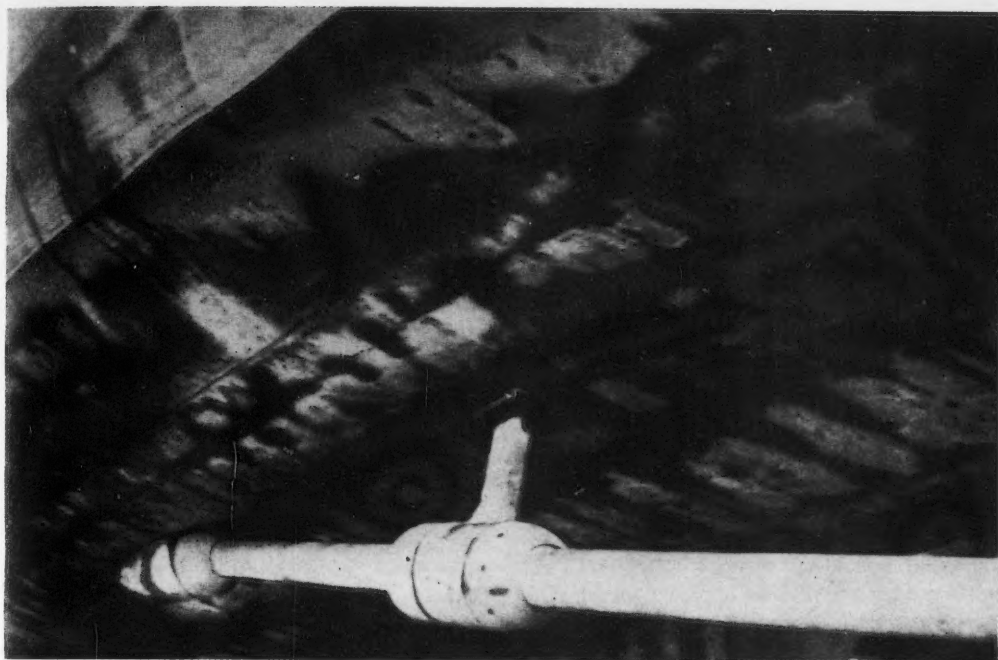
Figure 20—Extensive white scale deposits covering mill scale on a DE which was launched with the underwater hull unpainted. After 26 days outfitting no significant removal of mill scale had occurred.

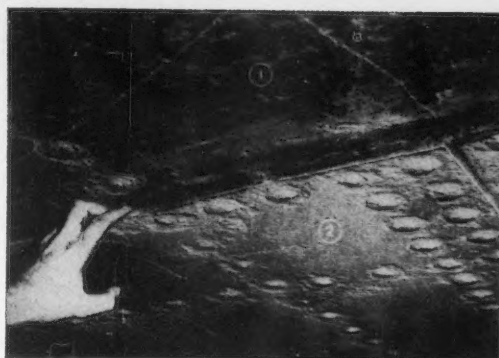
Figure 22—Accelerated corrosion of rivet points and plating. Vessel was twenty years old but a number of plates had been renewed about twelve months previously. The upper plate (1) is the original hull and the lower (2) is the new plate. Note attack on both plates caused by mill scale on the new plates.

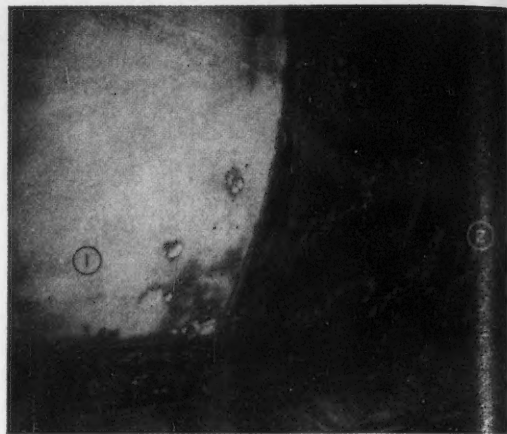
Figure 24—Effect of washcoat primer. The plate at left (1) was pre-coated with washcoat primer (0.0003-inch thick). All of the underwater body was then painted with a conventional five-coat bottom system. At the next docking, about four months later, the anti-corrosive paint was intact, in good condition and free from blistering on the washcoat primed plate. Some peeling of the anti-fouling coat occurred in the bottom right hand corner. The remainder of the conventional system on the adjoining plate (2) and elsewhere on the bottom had failed, even to bare metal in many locations.

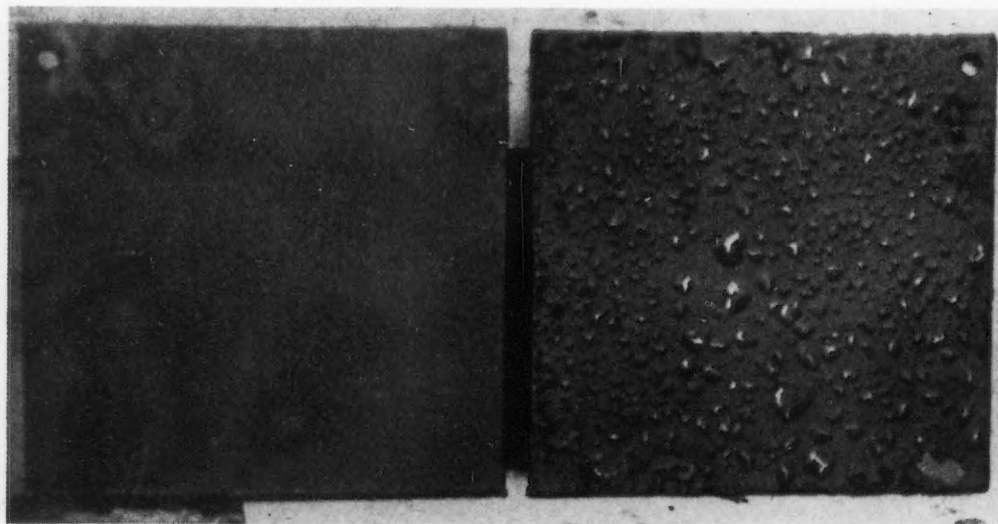
Figure 23—Test panels showing the beneficial effect of a washcoat primer in preventing blistering of paint. Both panels were sandblasted. Plate at left was coated with one coat of washcoat primer (0.0003-inch thick). Both panels were next painted with four coats of a conventional marine paint and immersed in sea water at Duxbury, Mass. Photograph was taken at 8 weeks—note extensive blistering up to 1/2-inch in diameter in panel at right. The first evidence of blistering on the panel at left occurred at 21 weeks immersion and at 40 weeks the blisters were scattered and less than 1/16-inch in diameter.

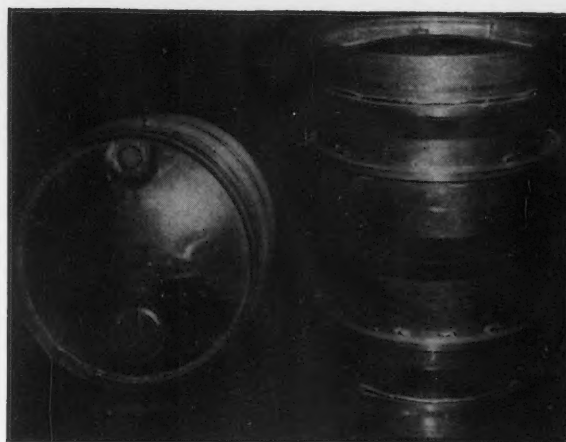
Figure 1—Aluminum alloy drum approved by the Interstate Commerce Commission (Specification 42B) for shipment of nitric acid (82 per cent by weight and above).

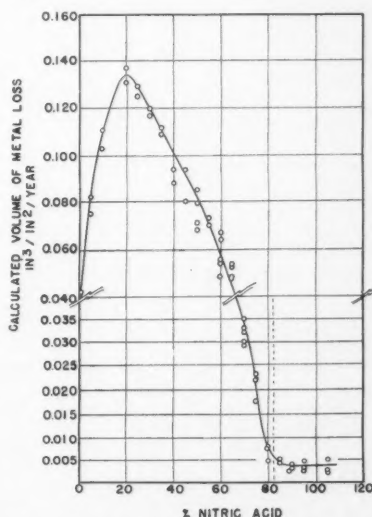
Figure 2—Effect of concentrations of nitric acid solutions at room temperature on the resistance of 2S-H14 to corrosion.
